ANNUAL REPORT FOR 2008

**Unnamed Tributaries to Doby Creek Mitigation Site
Mecklenburg County
TIP No. I-3803A**

Prepared By:
Natural Environment Unit & Roadside Environmental Unit
North Carolina Department of Transportation
September 2008

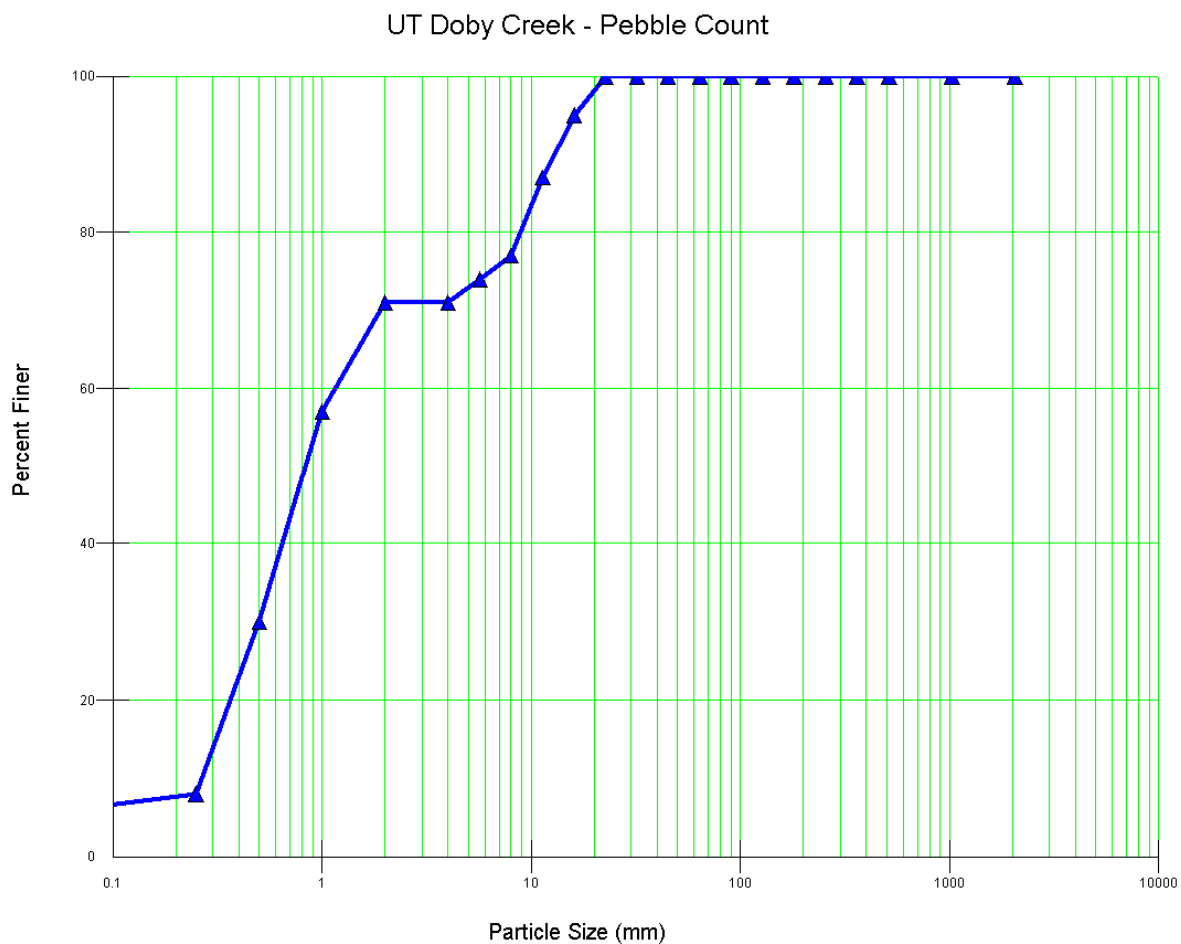
A representative pebble count was taken throughout the surveyed reach. This information is used to determine the stream type. Pre-construction data was not available for UT to Doby Creek. The pebble counts taken during the Year 2007 and Year 2008 monitoring period noted that the D_{50} (50 percent of the sampled population is equal to or finer than the representative particle diameter) for the entire reach of UT to Doby Creek was approximately 11.75 mm and 0.87 mm respectively, which is indicative of a sand-bed stream. The D_{50} has decreased in size since 2007 because a drainage ditch on the fill slope has eroded and some sediment has washed into the channel. The drainage ditch has stabilized itself for now. The D_{50} has classified this channel as a sand-bed stream for 2008 due to the finer particles deposited into the channel. A chart depicting the particle size distributions for UT to Doby Creek for the Year 2008 is presented below.
